Clunk Noise at Low Speeds when Stopping or Turning

Service Category Drivetrain

Section Automatic Transmission/Transaxle

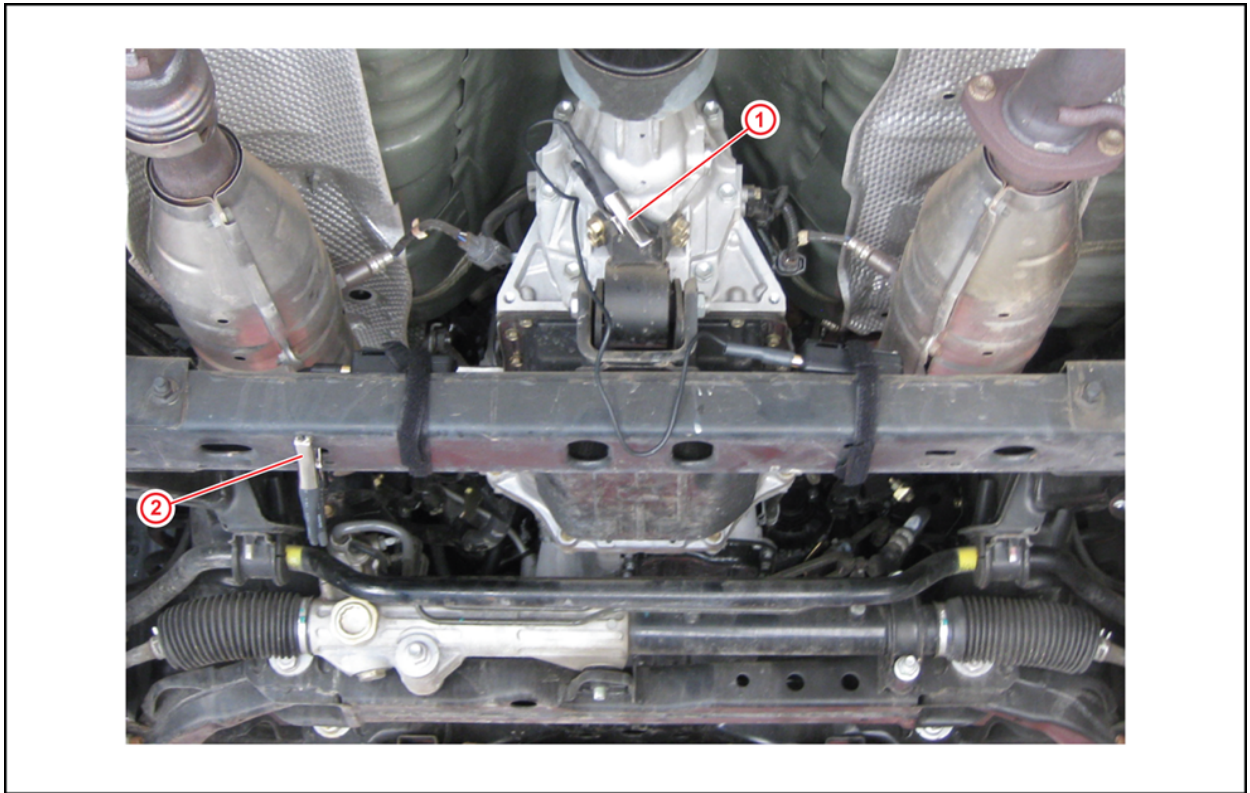
Figure 1.

1	ChassisEAR™ Sensor Mounted to Rear Transmission Mount
2	ChassisEAR™ Sensor Mounted to Frame Crossmember No. 3

3. With ChassisEAR™ installed, the noise should be very loud from the frame crossmember No. 3 pickup location and NOT heard on the rear transmission mount above the rubber section of the mount.

1. Place the vehicle on a lift and install ChassisEAR™ (or equivalent) on the following components to help isolate the source of the noise (see Figure 1):
 - On frame crossmember No. 3.
 - On rear transmission mount above rubber section of mount or on transmission extension housing assembly.

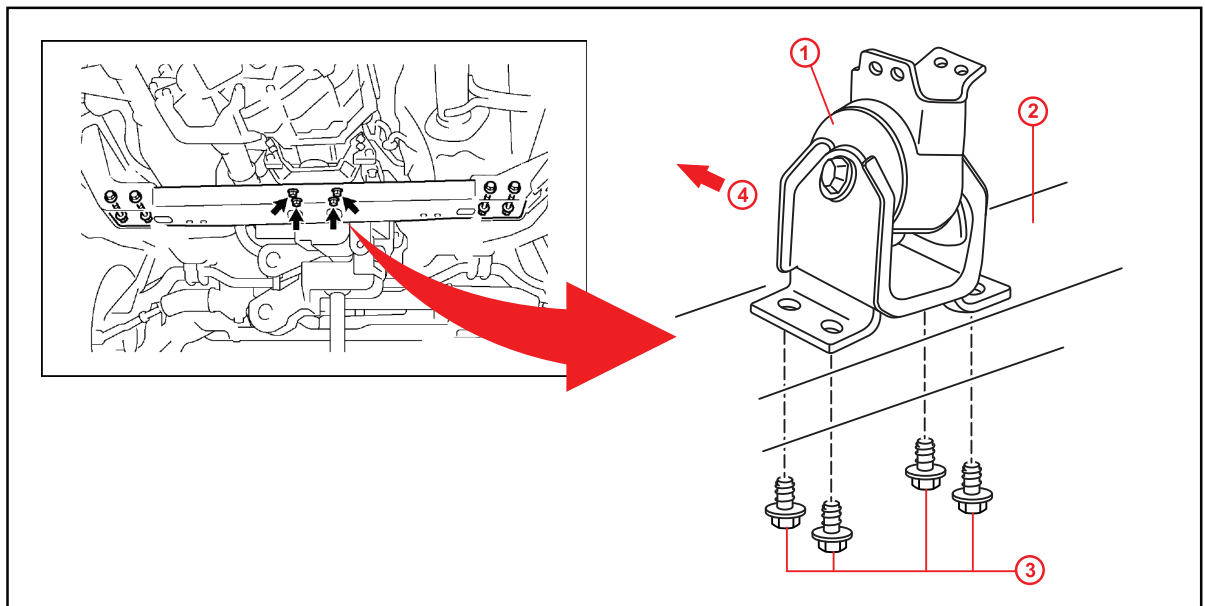
Figure 5.

1	Engine Mounting Rear Insulator (P/N 12371-0F080)
2	Frame Crossmember No. 3
3	Bolt w/Washer (P/N 90119-08895)
4	Front of Vehicle

- E. Install the NEW rear transmission mount (insulator, engine mounting rear) to the NEW frame crossmember No. 3 using the 4 NEW bolts.

Torque: 30 N*m (300 kgf*cm, 22.1 ft*lbf)

The torque value for these 4 bolts has been increased.

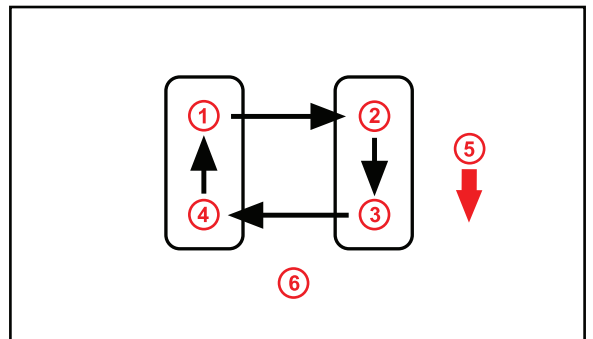
1-4	Bolt Tightening Order
5	Front of Vehicle
6	Bottom View

- G. Tighten all the bolts in steps D through F. Tighten the bolts retaining the NEW rear transmission mount (insulator, engine mount rear) to the NEW frame crossmember No. 3 in the order shown in Figure 7. Tighten bolt 1, then 2, then 3, then 4.

Torque: 30 N*m (300 kgf*cm, 22.1 ft*lbf)

Then tighten bolt 1 once again.
