Technical Service BULLETIN

ENGINE OIL LEAK

'07 Tundra (5.7 L, TMMI)

ENGINE
EG028-07

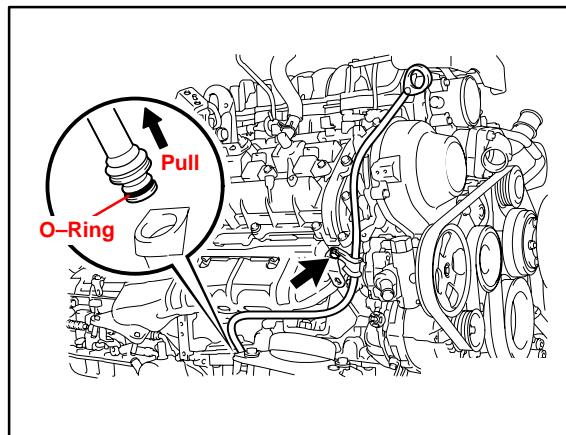
Introduction Some 2007 model year Tundra vehicles with a 5.7-liter engine may exhibit an oil leak from the oil pan area. This concern may be caused by a leaking O-ring on the dipstick tube. Use the following repair procedure to address the customer's concern.

1. Inspect leak location.
2. If the leak is found to be coming from the dipstick tube, remove the engine oil dipstick tube.
3. Remove the old O-ring from the dipstick tube.
4. Apply a light coat of engine oil to the NEW O-ring.
5. Install the NEW O-ring to the dipstick tube.
