## Technical Service BULLETIN

### HIGH BEAM INDICATOR LIGHT INOPERATIVE

'01 Sequoia

EL007-01

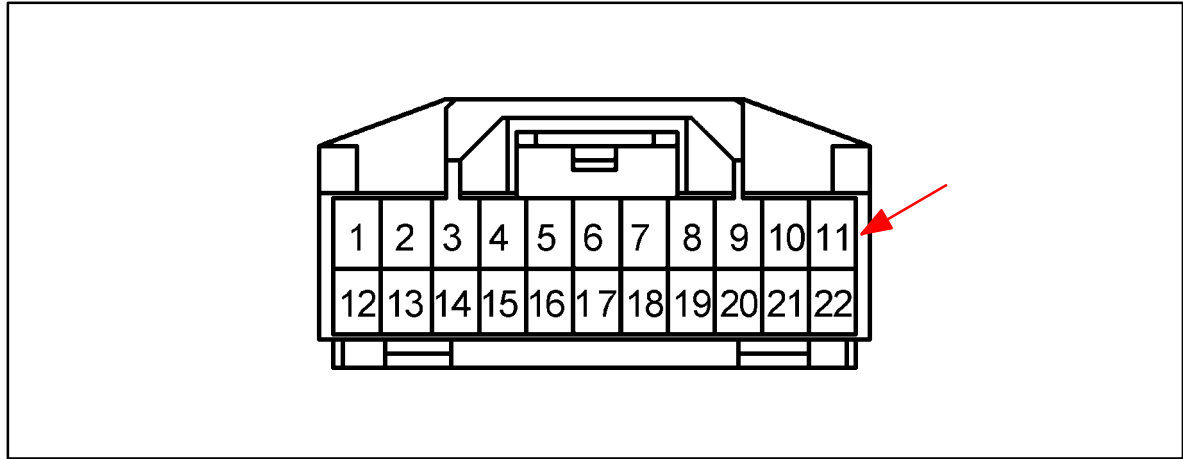
**Introduction** In rare cases, some owners of 2001 model year Sequoia vehicles equipped with Daytime Running Lights (DRLs) may experience a condition in which the High Beam Indicator Light does not illuminate when the high beams are turned on. A modification to the wiring harness and replacement of the Body ECU, as described below, should be performed to correct this condition.

1. Modify the high beam indicator circuit wiring.
  - A. Remove the Combination Meter. See page BO–88 in the 2001 Sequoia Repair Manual.
  - B. Locate connector C7 at the back of the combination meter.
  - C. Remove pin 11 (red and green wire) from the back of the connector.
